## Condition Report Blue Haven Terralong Village Kiama

Prepared by

ASSETFUTURE  
26<sup>th</sup> November 2025

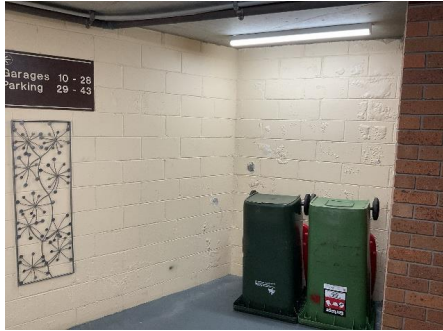
| Issue Number | Location | Issue/Defect | Image |
|---|---|---|---|
| 4 | Stage 2,<br>Level 1,<br>Corridor 2 | Paint bubbling | |

| Area | Recommended Actions |
|---|---|
| Stage 2 | <ul style="list-style-type: none"> <li>• Replace bubbling paint (Issue 4).</li> <li>• Replace concrete ceiling with concrete cancer (Issue 5).</li> <li>• Replace paint on balustrade (Issue 6).</li> <li>• Repair ceiling crack (Issue 7).</li> <li>• Pressure wash external brick walls, remove weeds in walls and roofs.</li> <li>• <b>Estimate:</b> greater than \$2,100</li> </ul> |

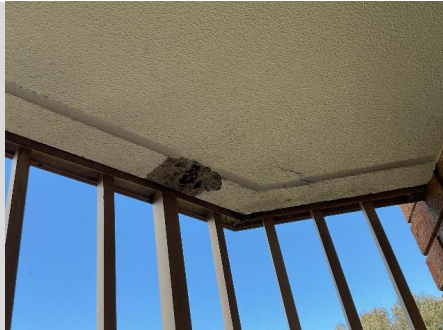
| Issue Number | Location | Issue/Defect | Image |
|---|---|---|---|
| 5 | Stage 2,<br>Level 3,<br>Corridor 2 | Concrete cancer<br>In front of unit 36 | |

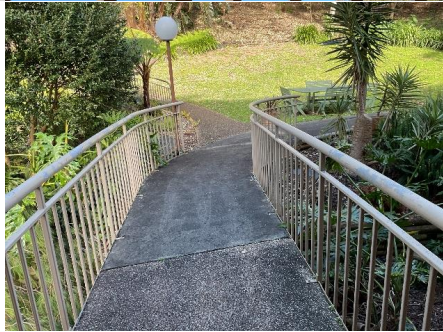
| Issue Number | Location | Issue/Defect | Image |
|---|---|---|---|
| 6 | Stage 2,<br>Level 3,<br>Walkway | Balustrade needs paint | |

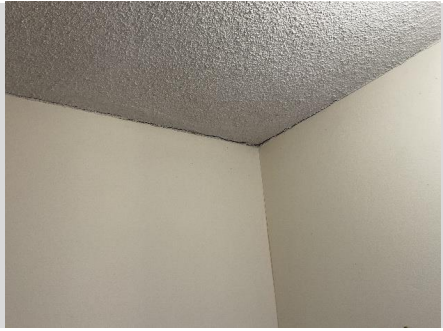
| Issue Number | Location | Issue/Defect | Image |
|---|---|---|---|
| 7 | Stage 2,<br>Level 6,<br>Stair 1 | Ceiling crack | |

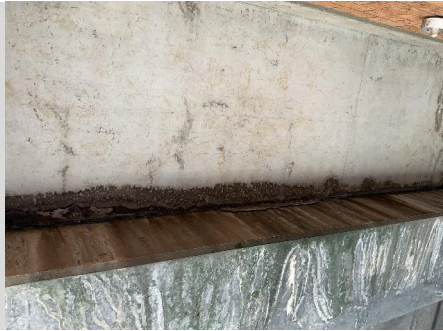
| Issue Number | Location | Issue/Defect | Image |
|---|---|---|---|
| 8 | Stage 3,<br>Level 1,<br>Garage | Concrete cancer<br><br>Close to the entry of<br>underground<br>garage between<br>stage 2 and 3 | |

| Area | Recommended Actions |
|---|---|
| Stage 3 | <ul style="list-style-type: none"> <li>• Replace concrete with concrete cancer (Issue 8)</li> <li>• Pressure wash external brick walls, remove weeds in walls and roofs.</li> <li>• Repair Dutch gables and roofs.</li> <li>• <b>Estimate:</b> greater than \$1,200</li> </ul> |

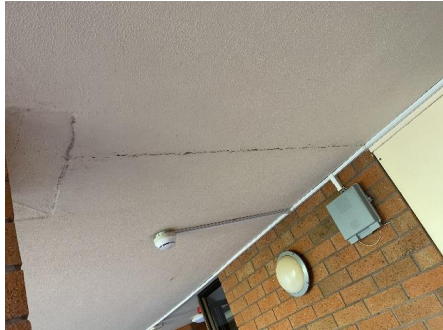
| Issue Number | Location | Issue/Defect | Image |
|---|---|---|---|
| 9 | Stage 4,<br>Level 2,<br>Corridor | Ceiling crack<br><br>Between Unit 102<br>and 103 | |

| Area | Recommended Actions |
|---|---|
| Stage 4 | <ul style="list-style-type: none"> <li>• Repair ceiling cracks along corridors (Issue 9, 10, 11).</li> <li>• Pressure wash external brick walls, remove weeds in walls and roofs.</li> <li>• Repair Dutch gables and roofs.</li> <li>• <b>Estimate:</b> greater than \$750</li> </ul> |

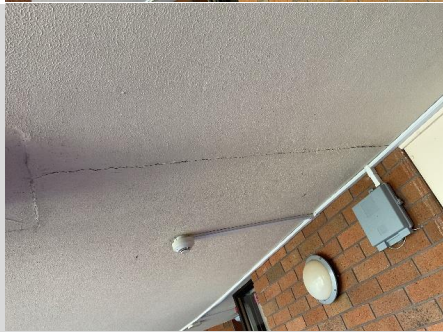
| Issue Number | Location | Issue/Defect | Image |
|---|---|---|---|
| 10 | Stage 4,<br>Level 3,<br>Corridor | Ceiling crack<br><br>Between units 112<br>and 113 | |

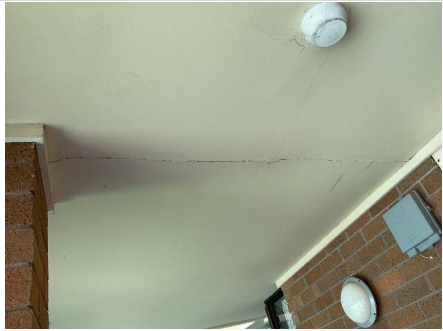
| Issue Number | Location | Issue/Defect | Image |
|---|---|---|---|
| 11 | Stage 4,<br>Level 4,<br>Corridor | Ceiling crack<br><br>Between units 122<br>and 123 | |

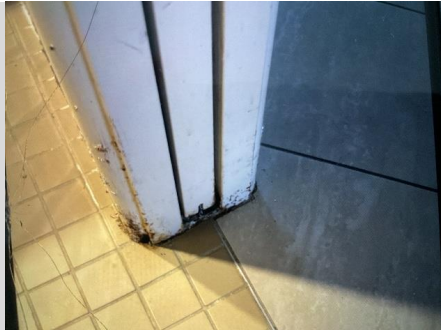
| Issue Number | Location | Issue/Defect | Image |
|---|---|---|---|
| 12 | Stage 5, Unit 519, Bathroom | Trim needs repainting<br><br>Door Trim showing signs of wear near floor.<br>Moisture identified. | |

| Area | Recommended Actions |
|---|---|
| Stage 5 | <ul style="list-style-type: none"> <li>• Repaint trim in unit 519 bathroom (Issue 12).</li> <li>• Repaint ceilings, rusted walls, louvres, and downpipes in external area. Requires scaffolding. (Issue 13).</li> <li>• Replace rusty cover plate in unit 710 bathroom (Issue 14).</li> <li>• Repair minor ceiling plaster cracks.</li> <li>• <b>Estimate:</b> greater than \$5,600</li> </ul> |

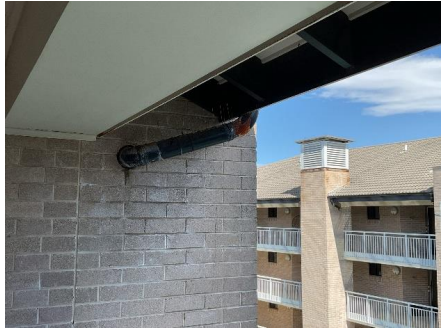
| Issue Number | Location | Issue/Defect | Image |
|---|---|---|---|
| 13 | Stage 5, Level 7 | Multiple rusty points in the external area | |

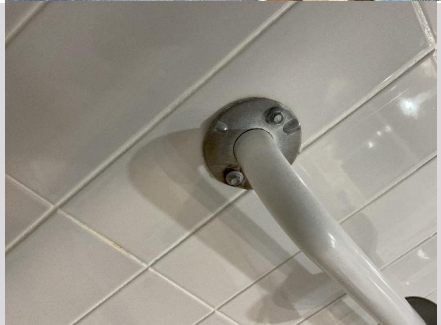
| Issue Number | Location | Issue/Defect | Image |
|---|---|---|---|
| 14 | Stage 5, Unit 710, Bathroom | Rusty Cover Plate<br><br>Leaking plumbing cover plate, plate is rusting and visible signs of moisture. Investigate and Fix.<br><br>Handle Plate replaced but it still rusty | |
