**Kendalls Cemetery and the Walls of Barroul - South Kiama Urban  
Release Area**

## **Conservation Management Plan**

Development Application Issue - Final Report

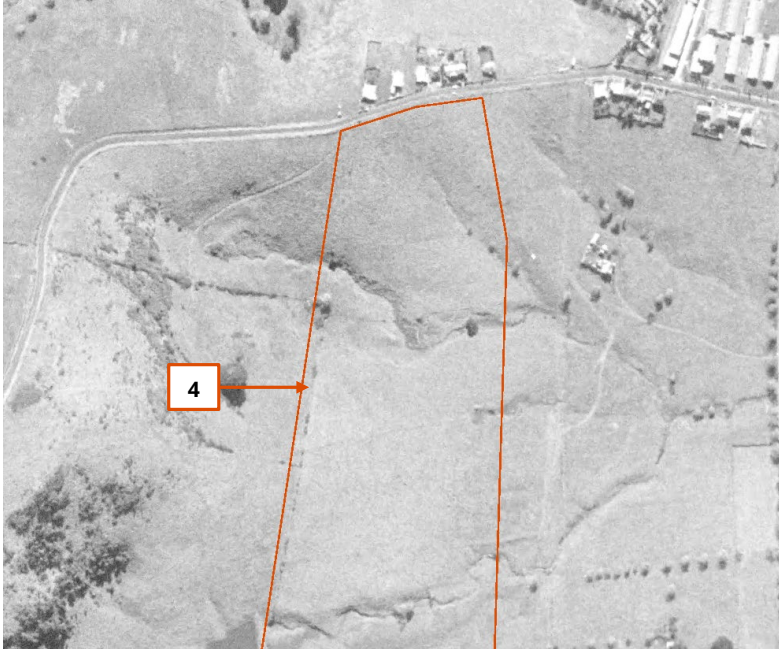
**Figure 17** 1970 aerial photograph, northern portion of study area, showing dry stone walls (Source: NSW Land and Property Information 2017)

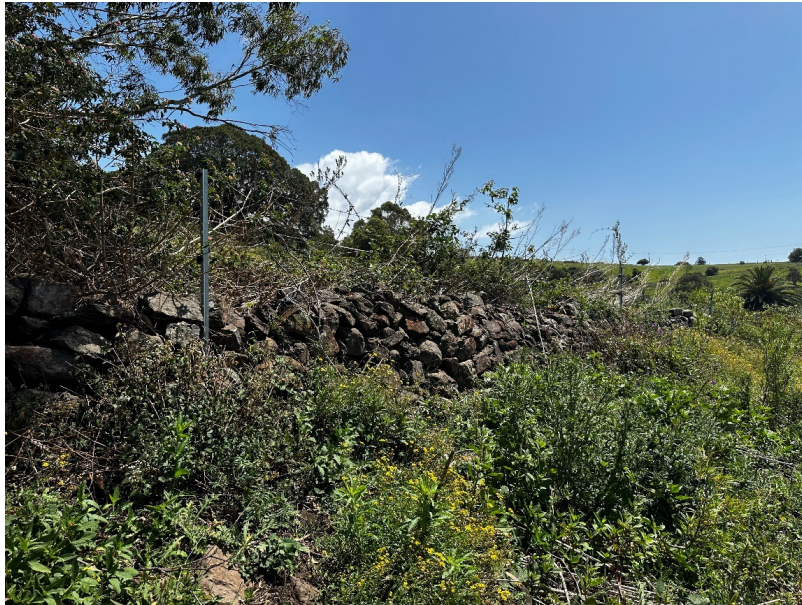
**Figure 45 Existing condition of the western boundary dry stone wall [4], facing north**

*Along the western boundary of the site, dry stone wall number 4 runs for approximately 1.9km. The northern end of wall 4 is in very poor condition and mostly tumbled down. Wall 4 is unaffected by the proposed subdivision.*

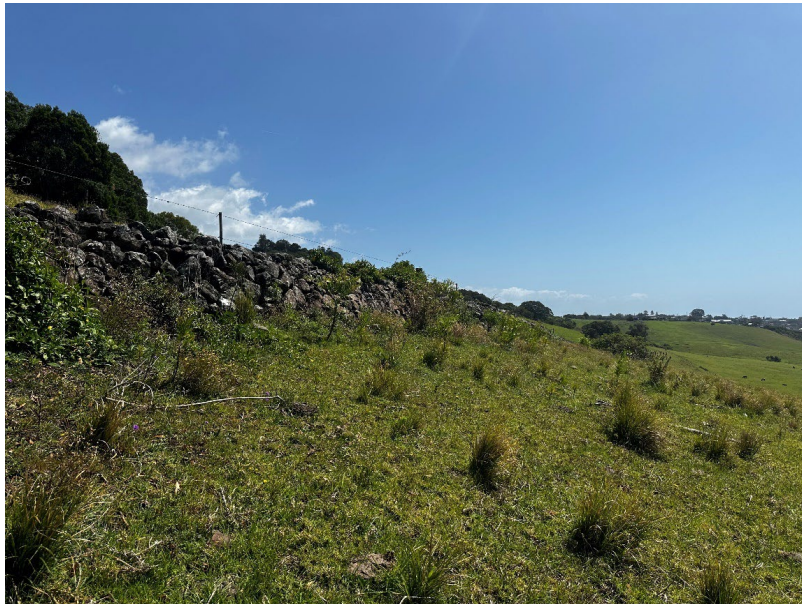
**Figure 46 View of the western boundary dry stone wall [4], facing north**

| Figure 46 | View of the western boundary dry stone wall [4], facing north ..... | 52 |

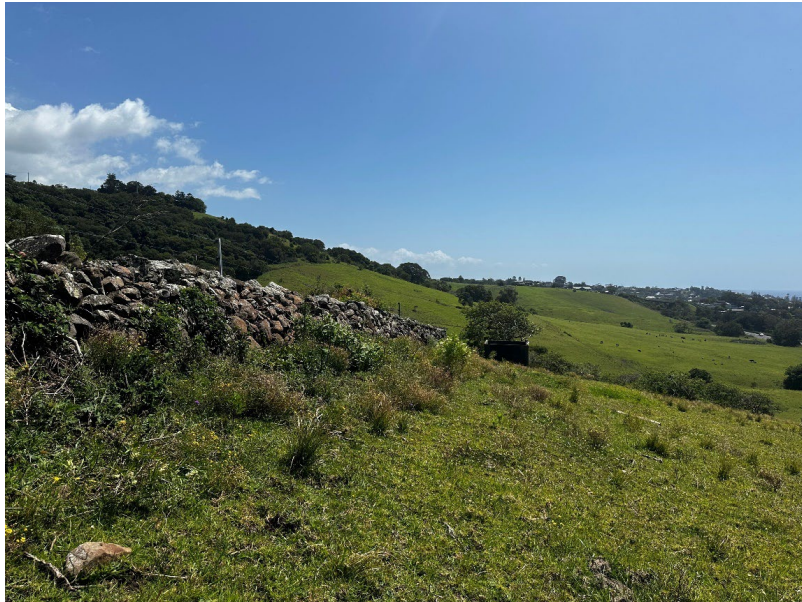
**Figure 47** View of the western boundary dry stone wall [4], facing north

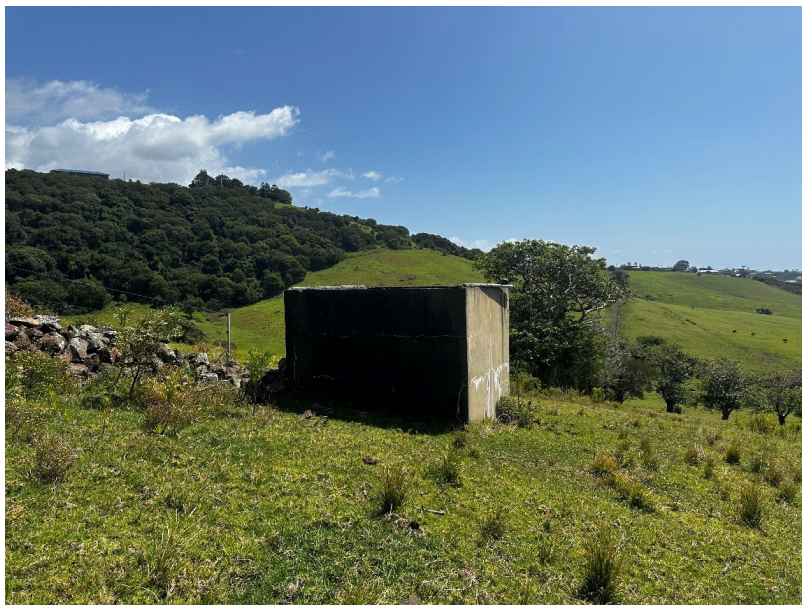
**Figure 48** View of the concrete structure [24] near the western boundary dry stone wall [4], facing north-west

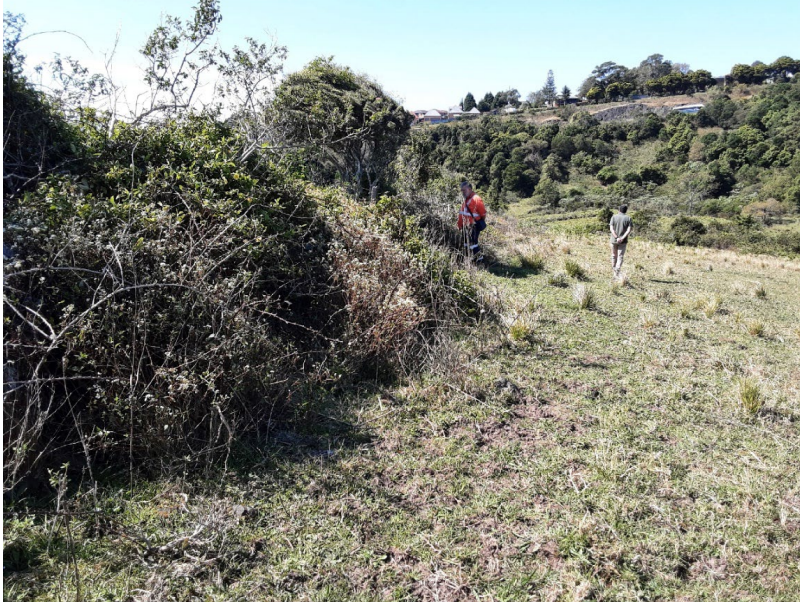
**Figure 49** View of dry stone wall [5] on the southern side of the study area, facing south east

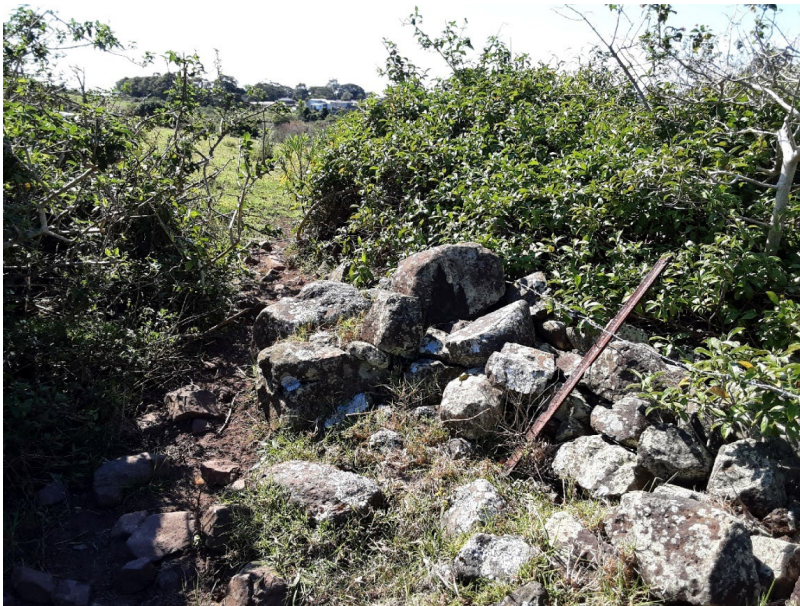
**Figure 50** View of dry stone wall [5] and dry stone wall [7] in the southern portion of the study area, facing south west

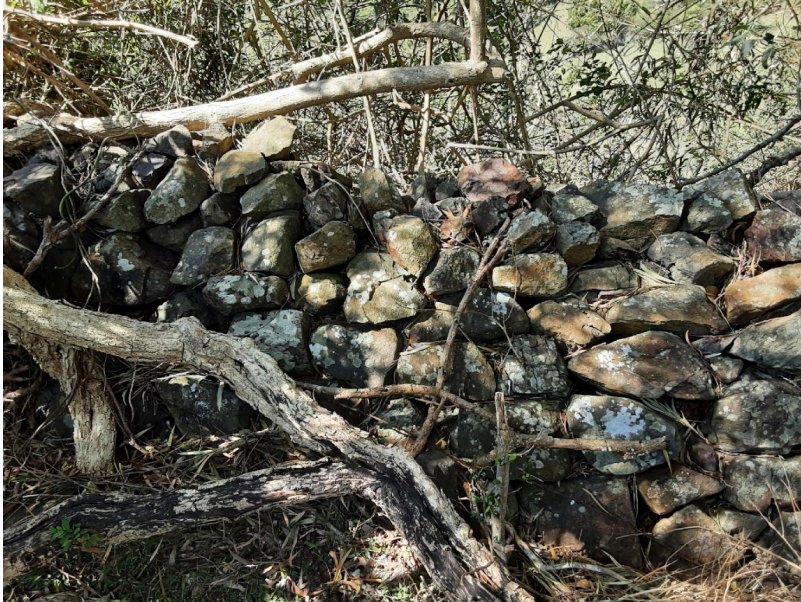
**Figure 51** View of dry stone wall [7] in the southern portion of the study area

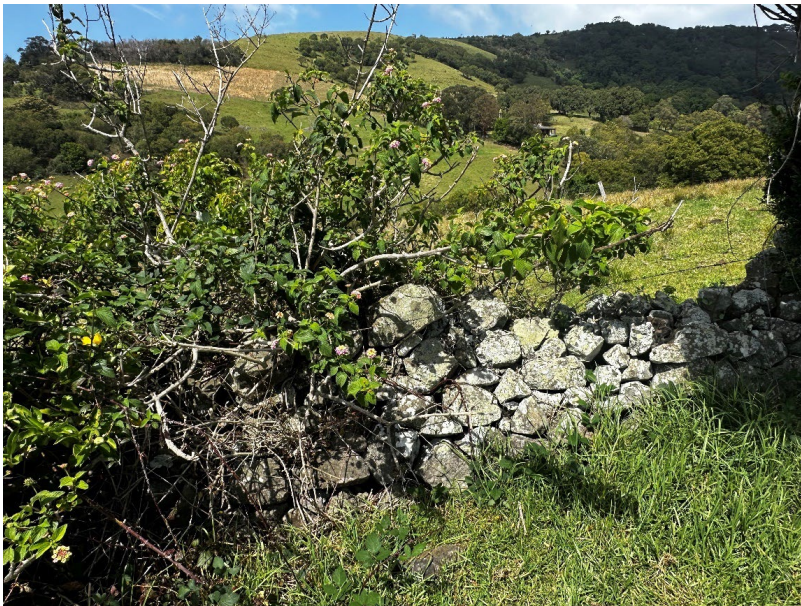
**Figure 52** View of dry stone wall [13] in the eastern portion of the study area overlooking the lower landscape, facing south-west

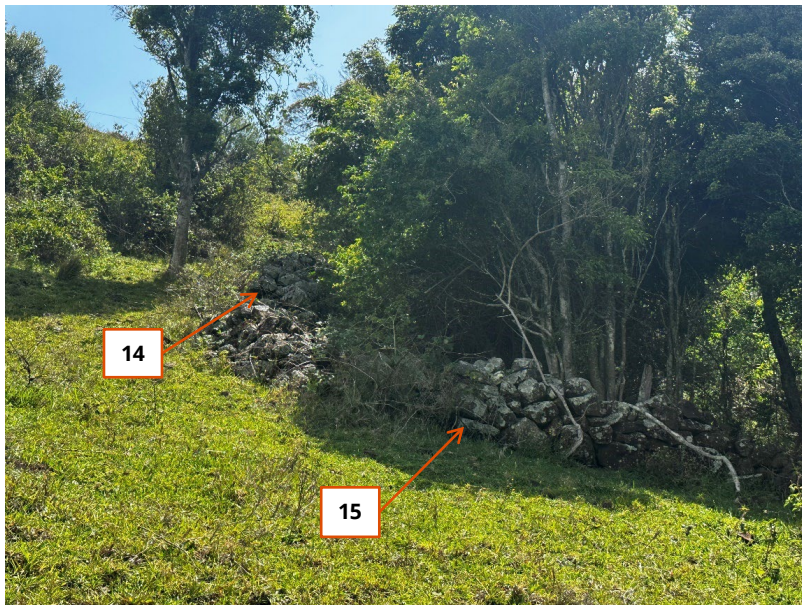
**Figure 53** View of dry stone walls [14] [15] within the central portion of the study area, facing south-east

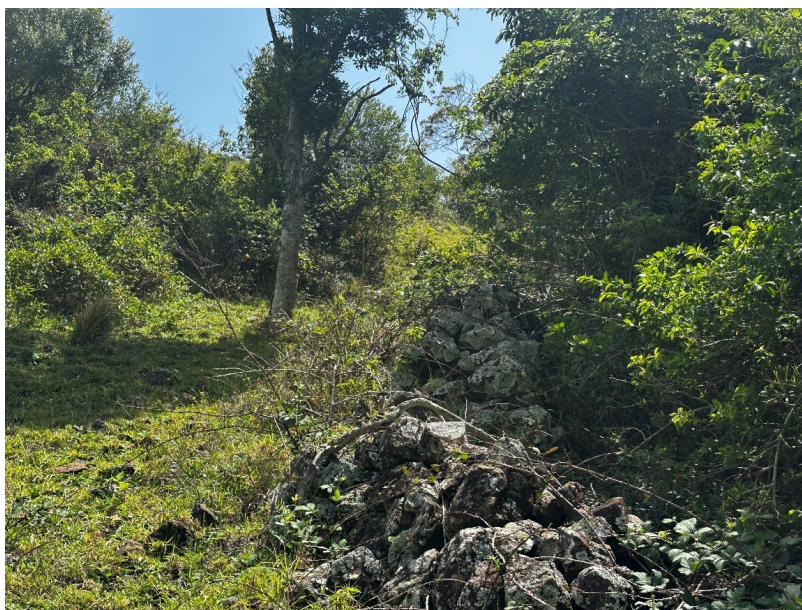
**Figure 54** View of dry stone wall [14] within the central portion of the study area, facing east

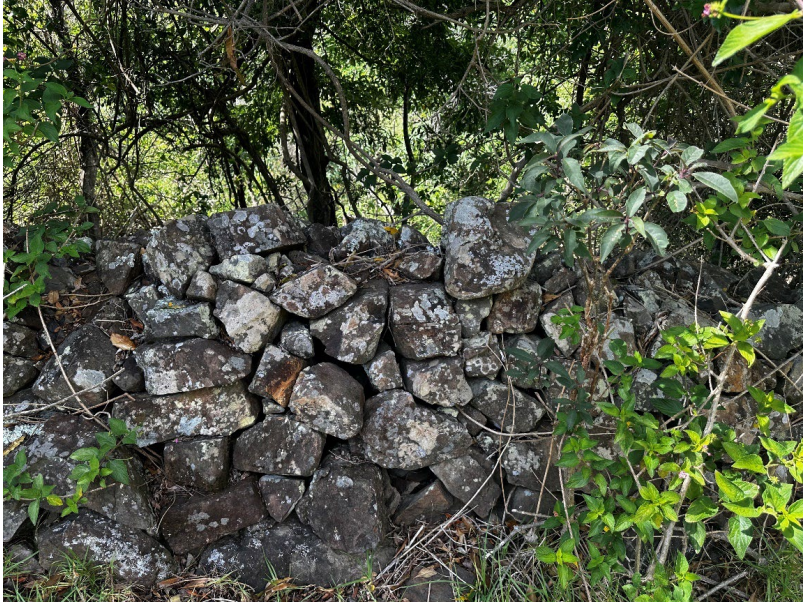
**Figure 55** Detailed view of the existing condition of dry stone wall [14]

| Kiama<br>Dry Stone<br>Walls<br>Inventory<br>No. | Wall no. | Description and condition | |
|---|---|---|---|
| <b>239/241</b> | 14, 16 | Wall 239<br>Good proportions: Not for the standard 'A' frame model<br>Type of foundation stones: Very large, deeply set and very rectangular<br>Face stones well interlocked: Relatively high considering scale of blocks<br>Good coping stones: No identifiable coping distinct from face rock<br>Intactness as a percentage: Average 90%, where visible and accessible<br>Wall 241<br>Not available. | Curving double stone wall in good to moderate condition to the north of Minna Munnora Creek. Weeds and trees grow along the length of the wall with the eastern extent obscured by vegetation.<br>Length: 45 metres |

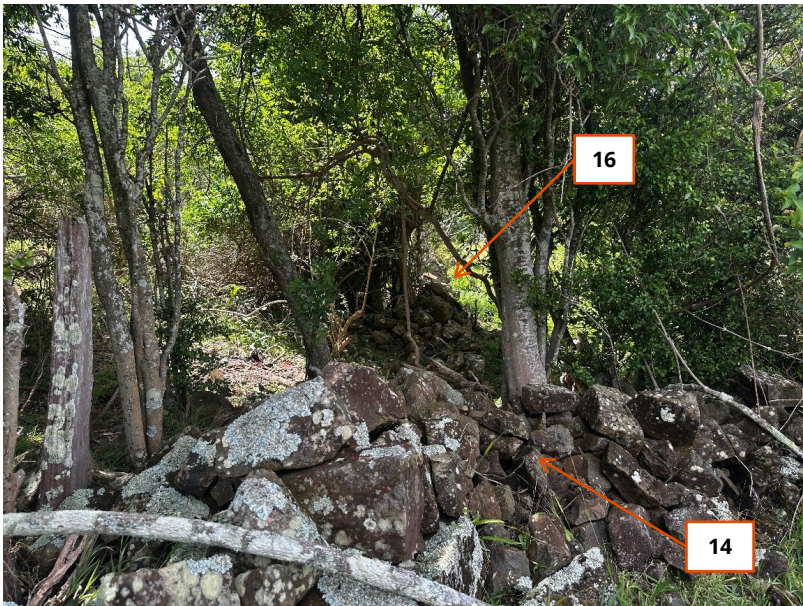
**Figure 56** Dry stone walls [14] [16] within the eastern portion of the study area, facing south east

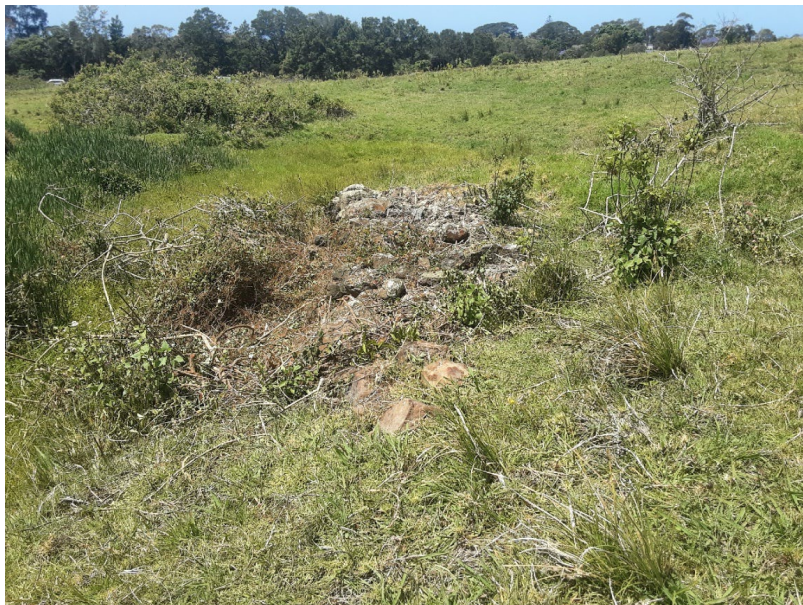
**Figure 57** Dry stone wall [22] within the northern portion of the study area

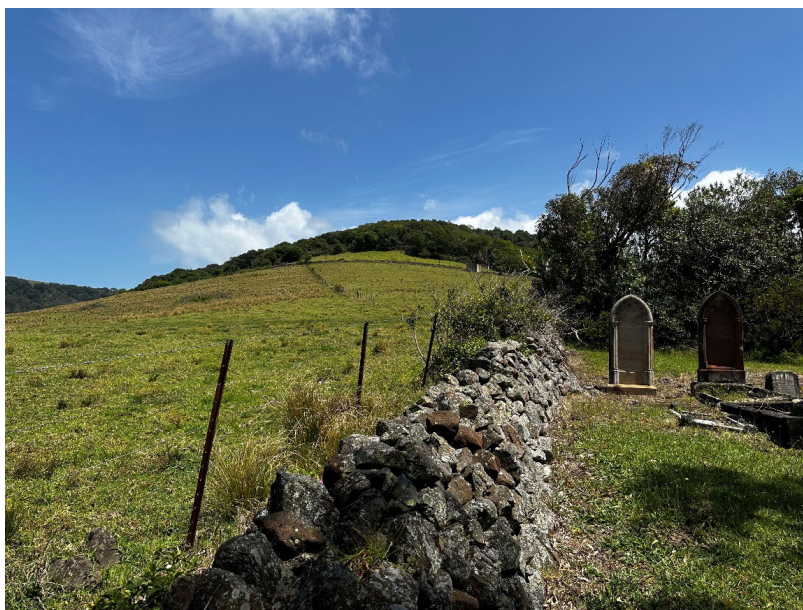
**Figure 63** View of the southern boundary of Kendall Cemetery [1] study area from east of Kendalls Cemetery [1] with dry stone wall [6]

| Kiama<br>Dry Stone<br>Walls<br>Inventory<br>No. | Wall no. | Description and condition | |
|---|---|---|---|
| | | | Double stone wall that forms the southern boundary of Kendalls Cemetery. The wall is in moderate condition with topstones missing in some places.<br>Length: approx. 50 metres |

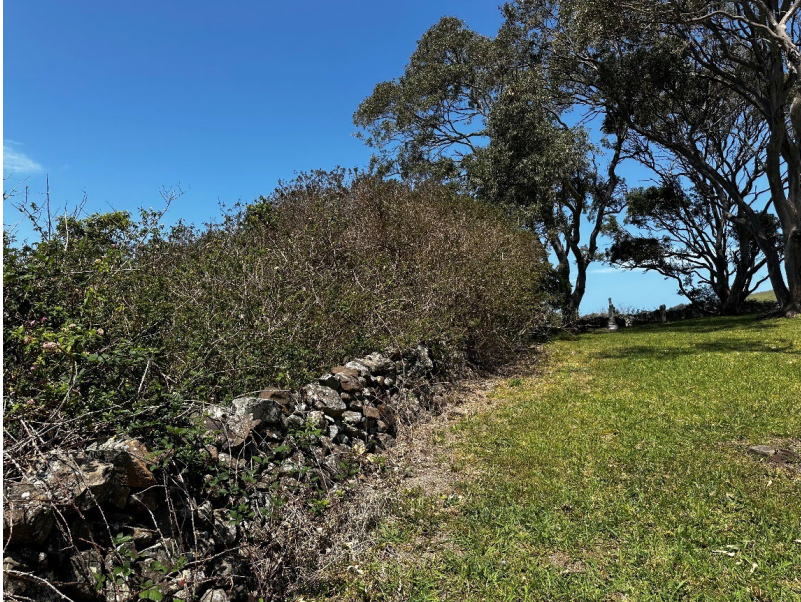
**Figure 64** View of the eastern cemetery boundary dry stone wall [6] from the north-eastern corner of Kendalls Cemetery [1], facing south

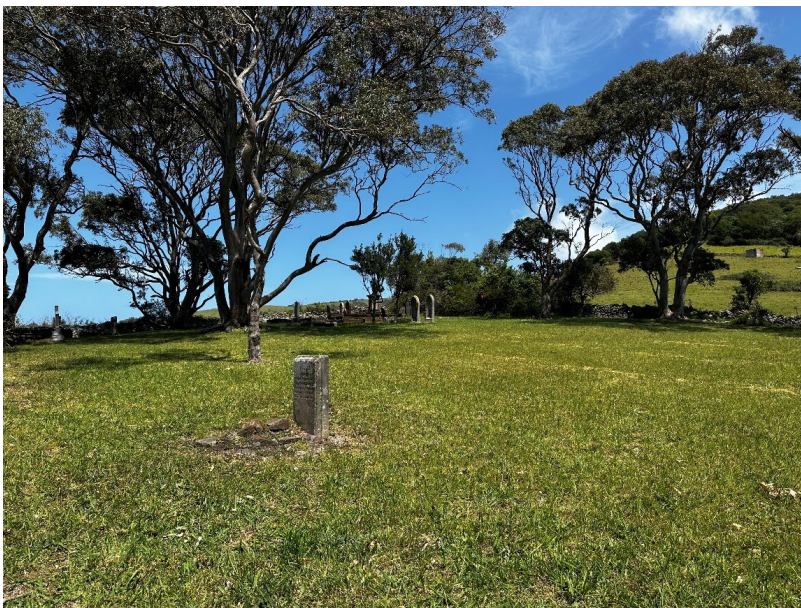
**Figure 65** View from the north-eastern corner of Kendalls Cemetery [1] with the cemetery boundary dry stone wall [6], facing south-west

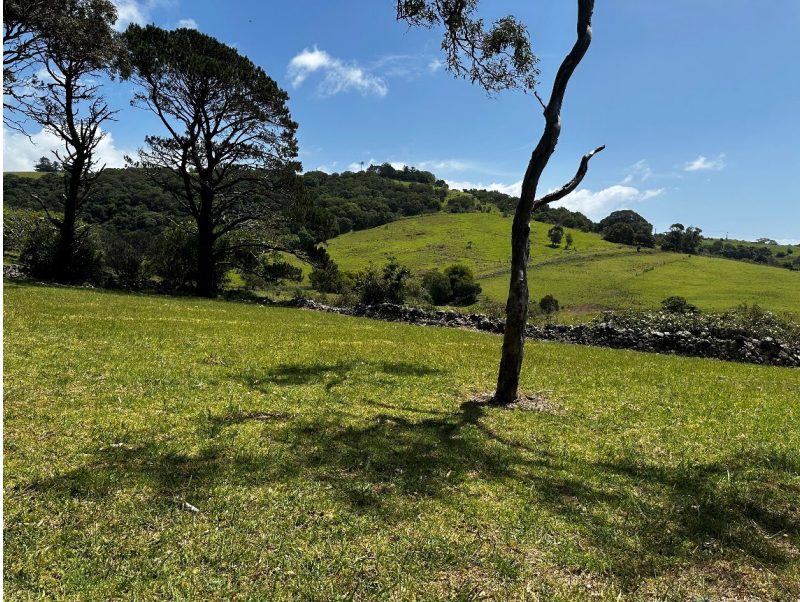
**Figure 66** View from the central portion of Kendalls Cemetery [1] with the cemetery dry stone wall [6], facing north-west

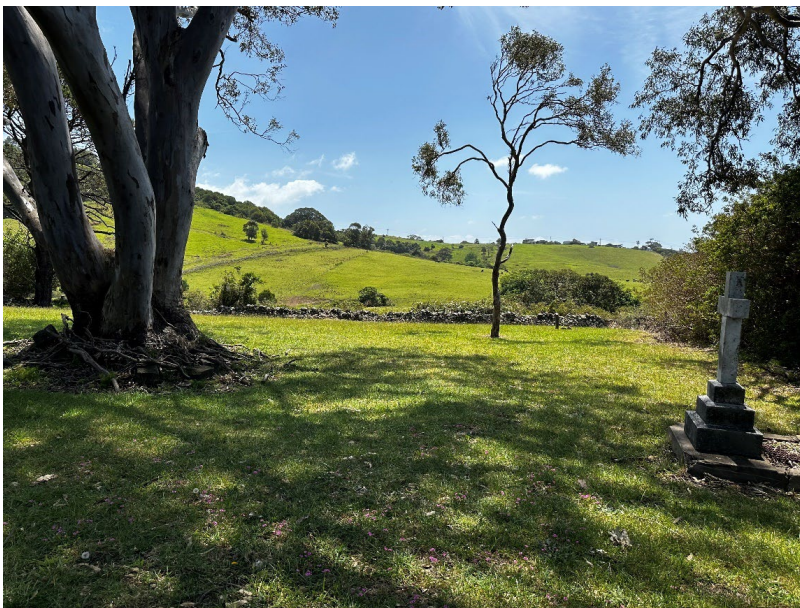
**Figure 67** View from the central portion of Kendalls Cemetery [1] with cemetery boundary dry stone wall [6], facing north

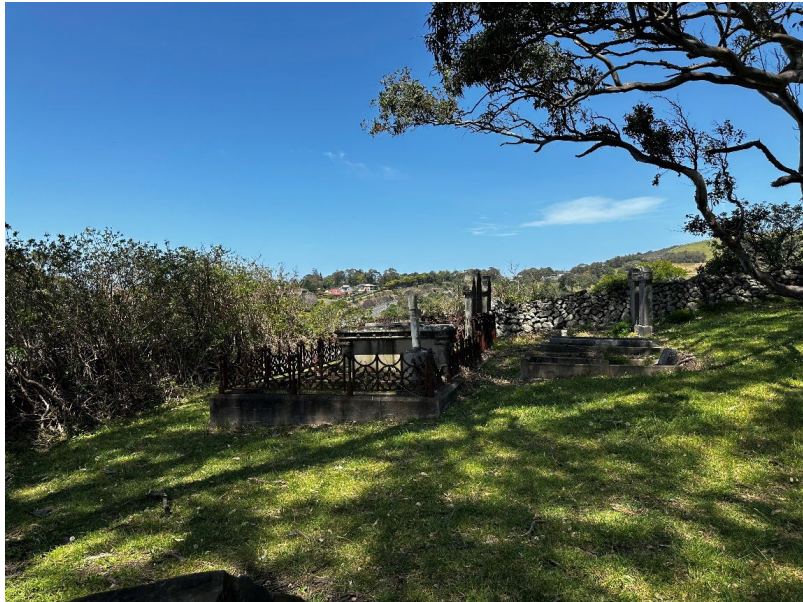
**Figure 68** View from the central portion of Kendalls Cemetery [1] with cemetery boundary dry stone wall [6], facing south

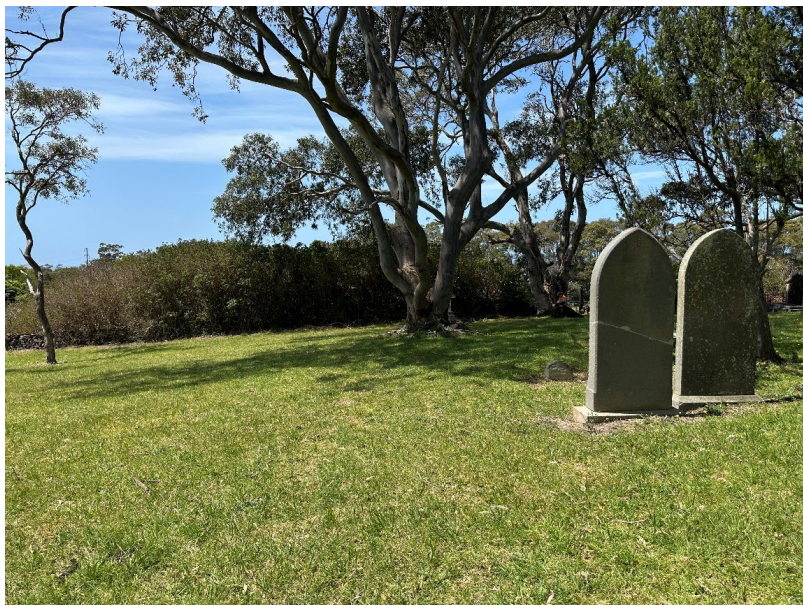
**Figure 73** View from the central portion of Kendalls Cemetery [1] of the cemetery boundary dry stone wall [6], facing east

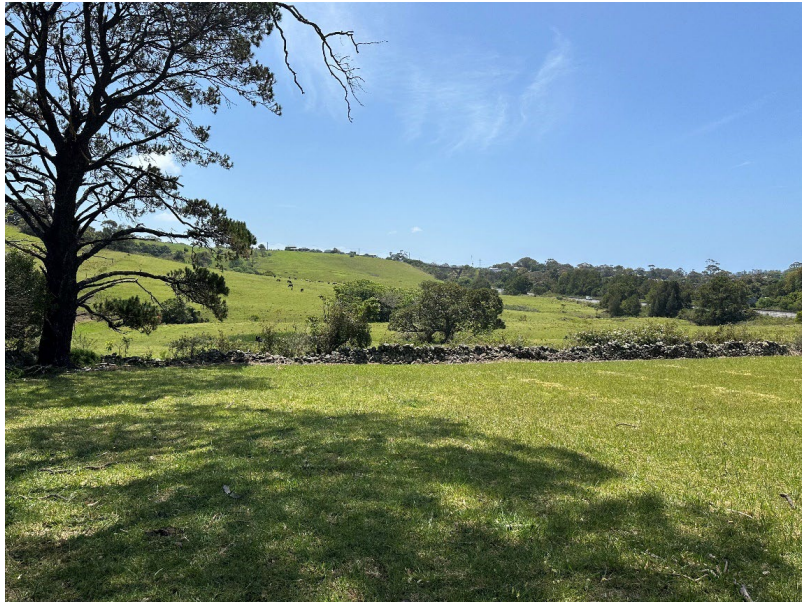
**Figure 74** View from the central-western portion of Kendalls Cemetery [1] with cemetery boundary dry stone wall [6], facing north

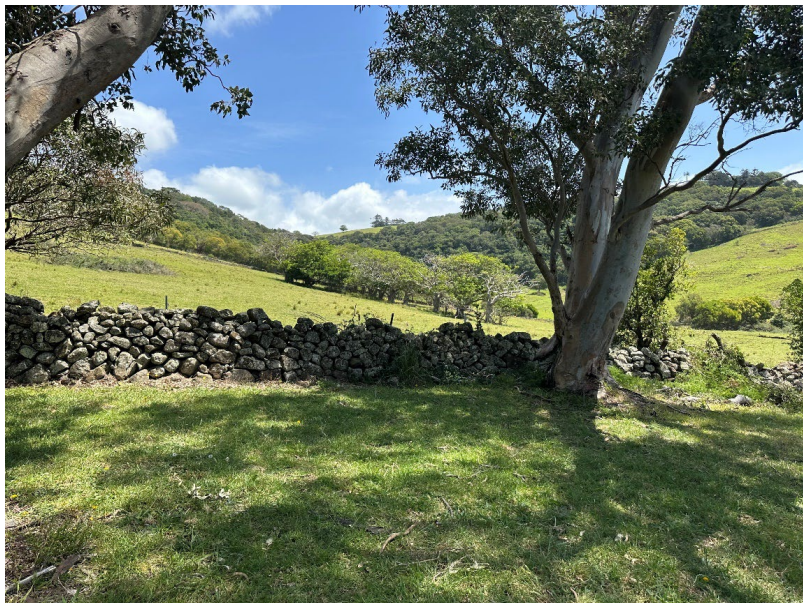
**Figure 76** View west from the central western portion of Kendalls Cemetery [1] with cemetery boundary dry stone wall [6]

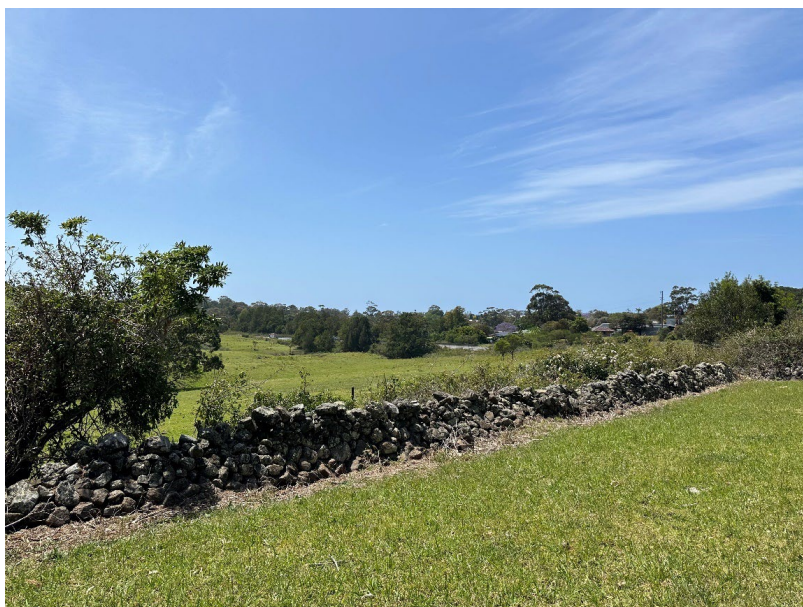
**Figure 77** View of the cemetery northern boundary dry stone wall [6] in the Kendall Cemetery [1]

| Kiama<br>Dry Stone<br>Walls<br>Inventory<br>No. | Wall no. | Description and condition | |
|---|---|---|---|
| 198 | 6 | Good proportions: Uneven face batter, but good<br>proportions<br>Type of foundation stones: Moderate-high base<br>course support<br>Face stones well interlocked: Especially along<br>middle part of western arm<br>Good coping stones: Generally coping layer has<br>been removed<br>Intactness as a percentage: Average 70-80%<br>around the four arms of the wall | Double stone wall that forms the northern<br>boundary of Kendalls Cemetery. The wall is<br>in poor condition and heavily degraded at<br>its western end.<br>Length: approx. 50 metres<br><br>Double stone wall that forms the eastern<br>boundary of Kendalls Cemetery. The wall is<br>in poor condition and mostly overgrown by<br>hedges.<br>Length: approx. 50 metres<br><br>Double stone wall that forms the western<br>boundary of Kendalls Cemetery. The wall is<br>in moderate condition with topstones<br>missing in some sections and some impacts<br>from vegetation growth.<br>Length: approx. 50 metres |

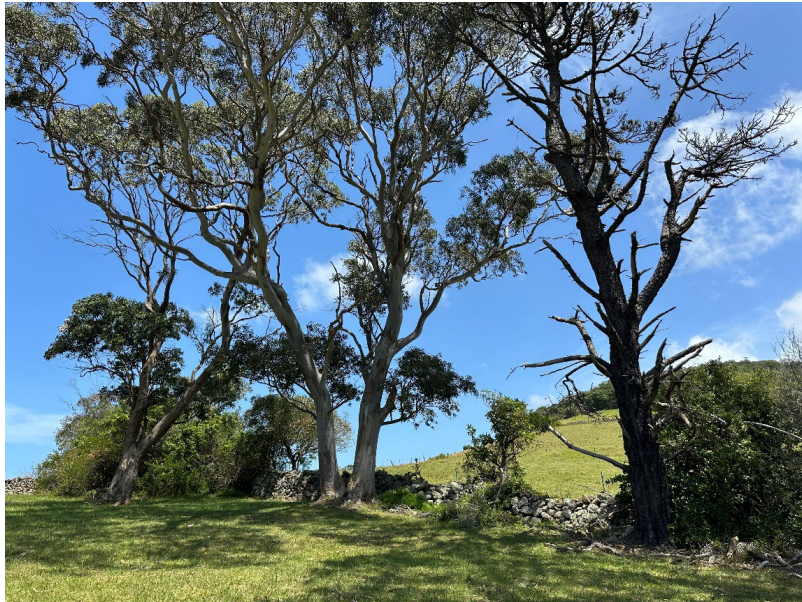
**Figure 78** View from the northern portion of Kendalls Cemetery [1] with cemetery boundary dry stone wall [6], *Eucalyptus smithii* and *Pinus radiata* facing south-west

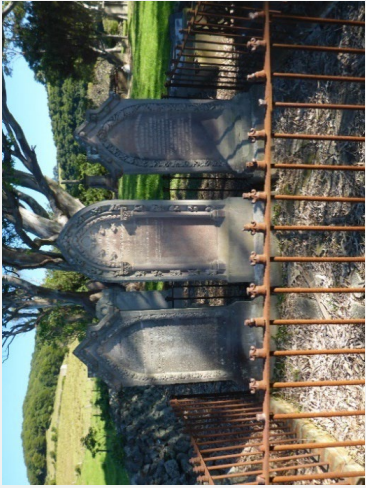
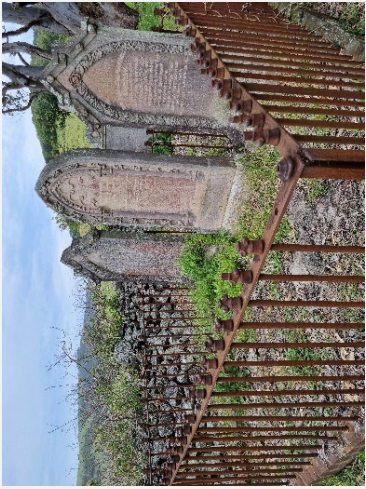
| Figure | Biosis 2017 survey | Biosis 2024 survey | Observations |
|---|---|---|---|
| <b>Figure 80</b><br>Headstone memorials surrounded by low fence lines | | | <ul style="list-style-type: none"><li>• Additional lichen growth.</li><li>• No apparent degradation of headstone or fencing.</li><li>• Unmanaged vegetation growth.</li></ul> |

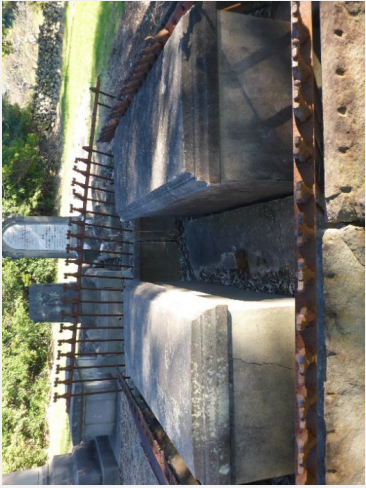
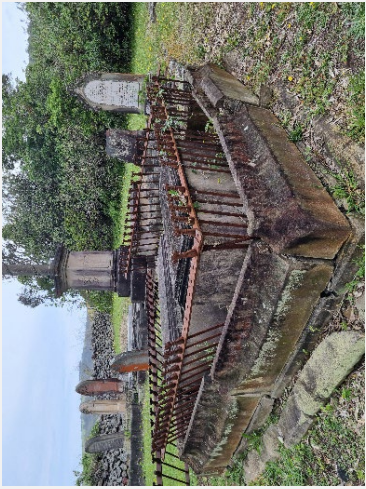
| Figure | Biosis 2017 survey | Biosis 2024 survey | Observations |
|---|---|---|---|
| <b>Figure 81</b><br>Raised horizontal slab memorials surrounded by derelict low fence lines | | | <ul style="list-style-type: none"><li>• No observable change apart from slight repositioning of iron fence and vegetation growth.</li></ul> |

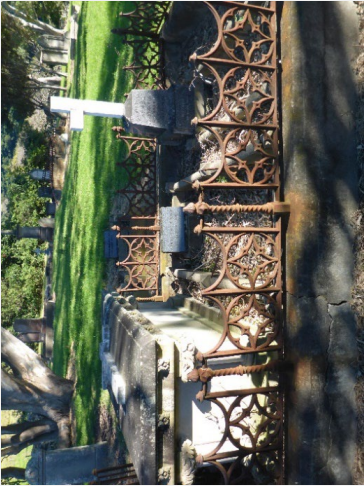
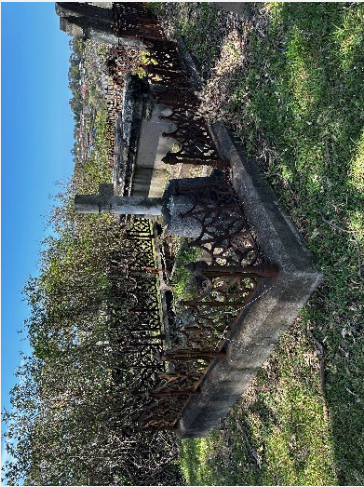
| Figure | Biosis 2017 survey | Biosis 2024 survey | Observations |
|---|---|---|---|
| <b>Figure 82</b><br>Raised horizontal slab with crucifix, memorial plaque with stone kerbing and crucifix memorial with stone kerbing | | | <ul style="list-style-type: none"><li>• Additional lichen growth.</li><li>• Possible minor weathering of stone.</li><li>• Vegetation growth and fallen bracken.</li></ul> |

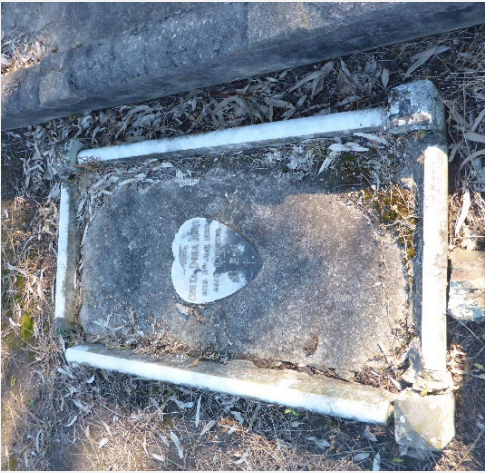
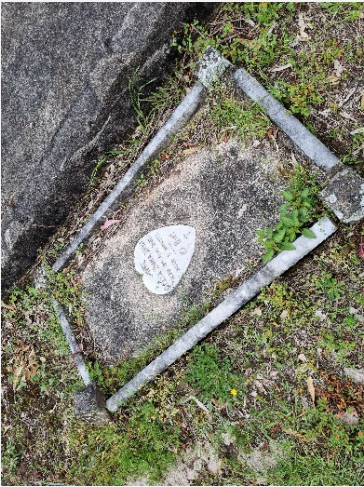
| Figure | Biosis 2017 survey | Biosis 2024 survey | Observations |
|---|---|---|---|
| <b>Figure 83</b><br>Horizontal slab and memorial plaque with stone kerbing | | | <ul style="list-style-type: none"><li>• Engraving stone has been cleaned along with sandstone around it.</li><li>• South-western corner stone of kerbing has been repositioned into place (previously just sat adjacent to eastern kerb).</li><li>• Weathering on kerbing stone.</li></ul> |

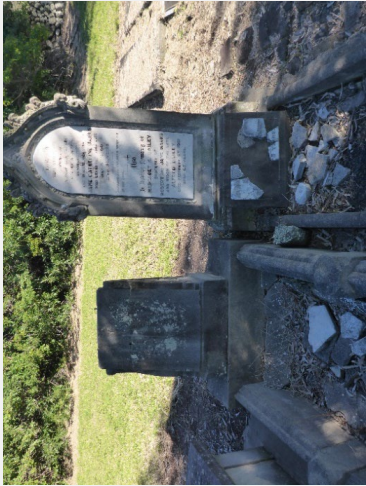
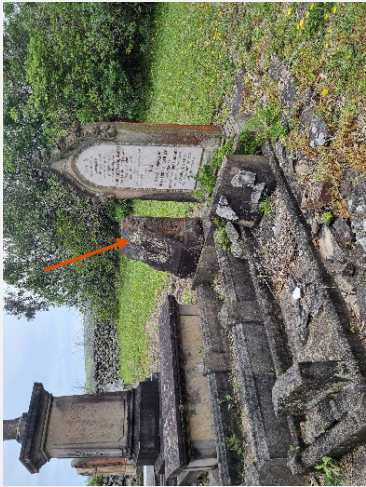
| Figure | Biosis 2017 survey | Biosis 2024 survey | Observations |
|---|---|---|---|
| <b>Figure 84</b><br>Memorial headstones<br>with stone kerbing | | | <ul style="list-style-type: none"><li>Crack more pronounced on centre upper portion of memorial stone on left side grave (indicated by arrow).</li><li>More lichen growth.</li><li>Increased vegetation.</li></ul> |

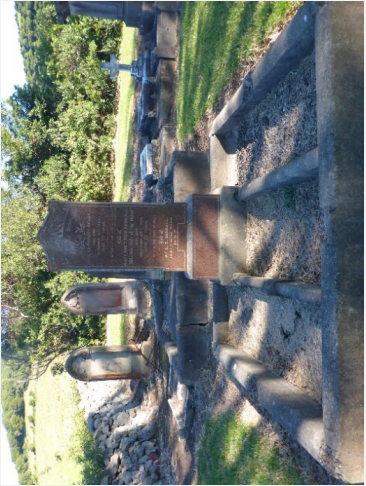
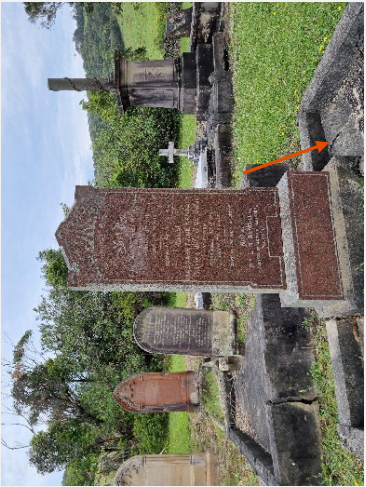
| Figure | Biosis 2017 survey | Biosis 2024 survey | Observations |
|---|---|---|---|
| <b>Figure 85</b><br>Memorial headstone<br>with stone kerbing and<br>stone plot outline | | | <ul style="list-style-type: none"><li>Some cracking to visible part of right-side grave slab at western end (indicated by arrow).</li><li>Minimal vegetation growth.</li></ul> |

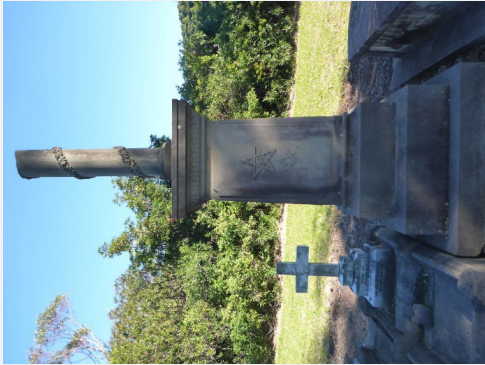
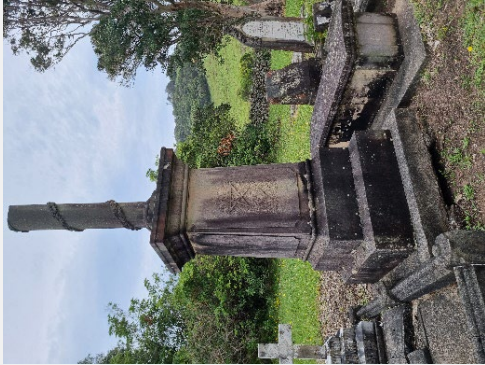
| Figure | Biosis 2017 survey | Biosis 2024 survey | Observations |
|---|---|---|---|
| Figure 86 Grave marker of John Black, former mayor of Kiama, view west | | | <ul style="list-style-type: none"><li>• Additional lichen growth and weathering.</li><li>• Possibly loss of soil underneath base through erosion/wash out.</li><li>• No observable damage to stone.</li></ul> |

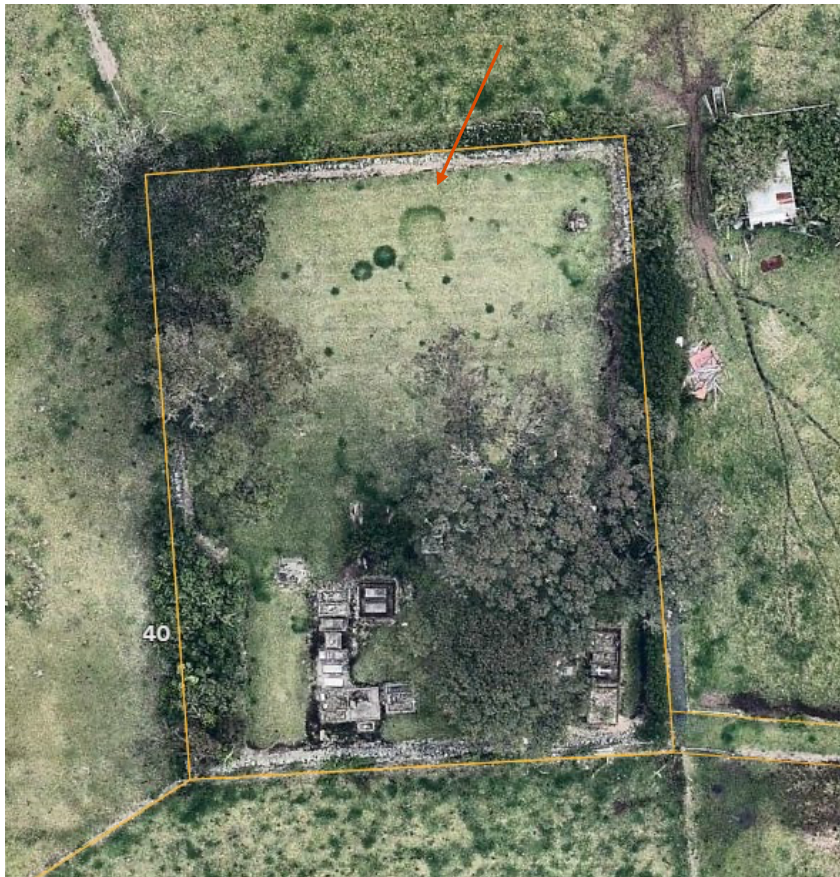
**Figure 87** October 2018 aerial photograph of Kendalls Cemetery, with the orange arrow indicating buried features (Source: Nearmap 2024)

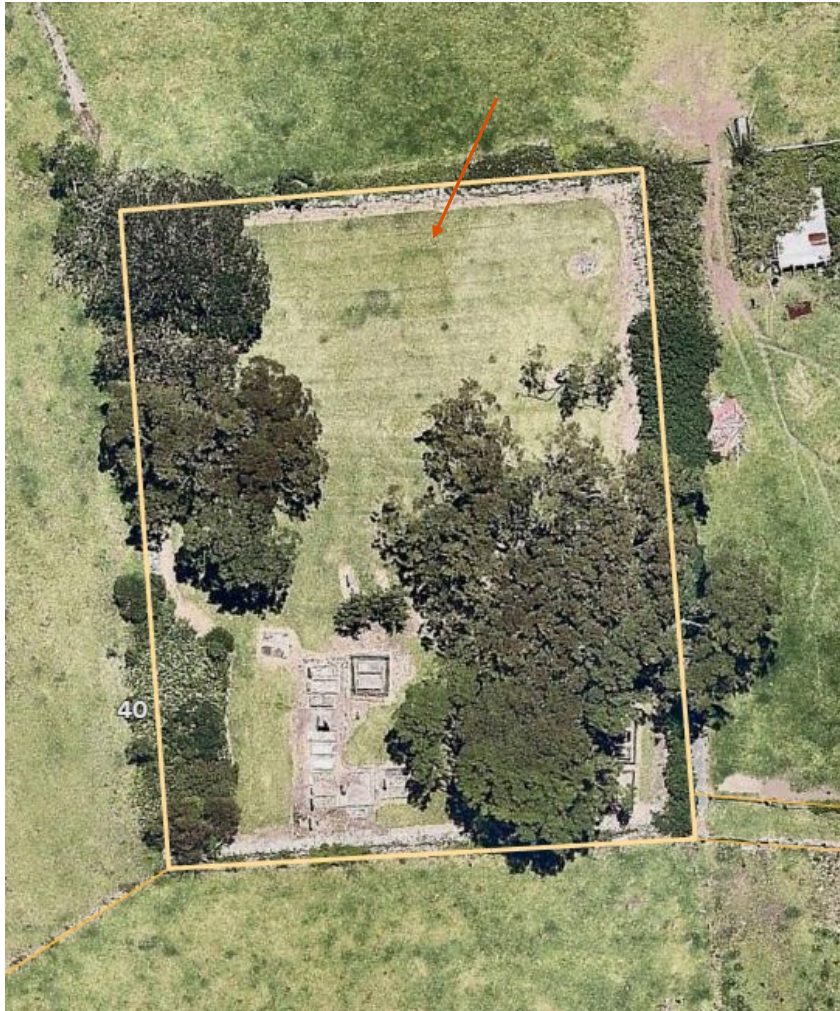
**Figure 88 December 2018 aerial photograph of Kendalls Cemetery, with the orange arrow indicating buried features (Source: Nearmap 2024)**

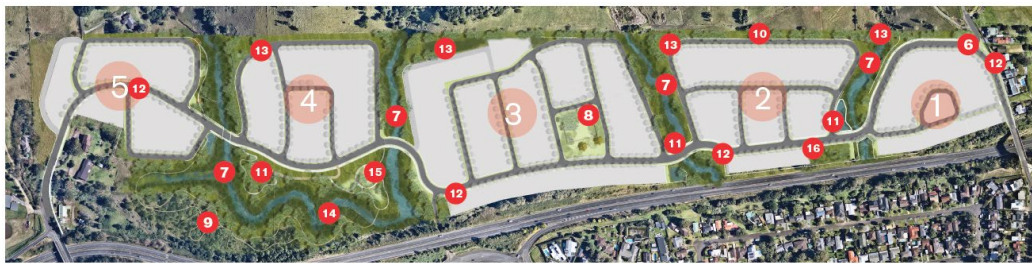
| 1 Character Area 1 – Ridgeway Gateway | 6 Entry Signage Location | 10 Retained Dry Stone Walls | 14 Munna Munnora Creek |

**Figure 91 Concept plan for SKURA as illustrated in Kiama DCP Chapter 12.11 SKURA with Kendalls Cemetery identified within 'Village 3' as feature 8 (Source: Draft Kiama DCP Chapter 12.11 SKURA)**

WCD intends to develop the place as a suburban residential subdivision (Figure 91). The subdivision would establish roads and open space—including both the cemetery and its setting, and areas for ecological conservation—together with residential lots under individual title. If realised, the ownership would be divided into the private domains of individual lots and the public domain.

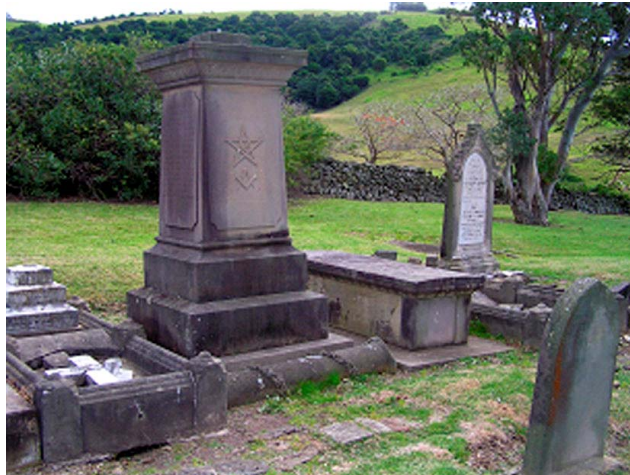
**Caption:** Masons guild inscription, headstone of Chapman
